**Flood Control Project Maintenance
Levee Inspections****LMA District Cover Sheet****Spring 2012 Levee Inspection Results****Reclamation District No. 0554 Walnut Grove**

Spring 2012 Levee Inspection Results

Reclamation District No. 0554 Walnut Grove

Waterway			Bank	Unit Miles
Unit No. 01 Sacramento River			Left	1.09
	Spring (March - May)	Summer (June - August)	(September - November) Fall	Winter (December - February)
Unit Maintenance Rating (Fall Only)				
Date of Inspection	3/27/2012 - 3/27/2012			
DWR Inspector	Herman Phillips			
Accompanied By	Gilbert Labrie DCC Engineering Co., INC.

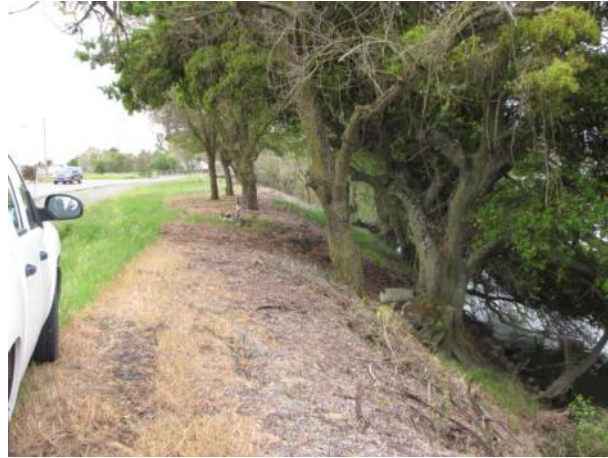
Levee Mile Report Line	4
Start Levee Mile	0.00
End Levee Mile	0.00
Location	Land Side
Category	Earthen Levee
Item	Vegetation

RD 554 levee mile 0.00 looking downstream from waterside shoulder. Photo taken 3-18-2012.

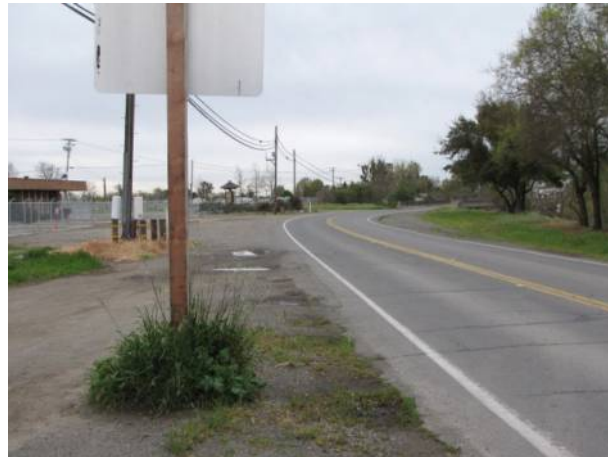
Levee Mile Report Line	5
Start Levee Mile	0.00
End Levee Mile	0.00
Location	Land Side
Category	Earthen Levee
Item	Vegetation

RD 554 Levee mile 0.00 landward shoulder. Photo taken 3-27-2012

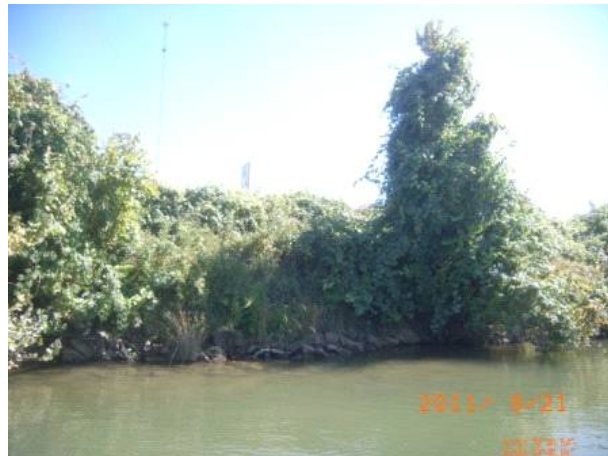
Levee Mile Report Line	6
Start Levee Mile	0.18
End Levee Mile	0.29
Location	Water Side
Category	Supplemental
Item	USACE Erosion Survey

USACE 2011 Photo #1

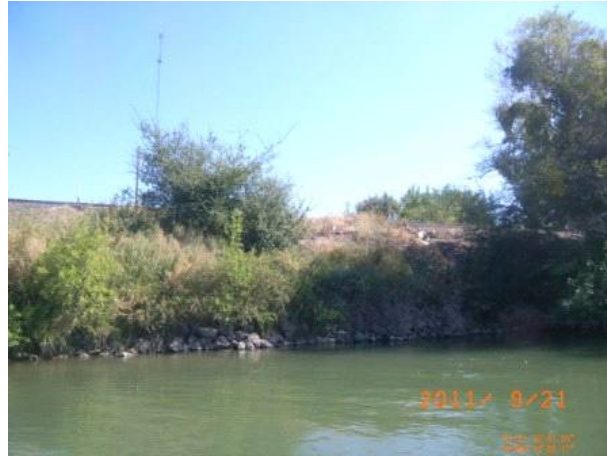
Levee Mile Report Line	6
Start Levee Mile	0.18
End Levee Mile	0.29
Location	Water Side
Category	Supplemental
Item	USACE Erosion Survey
USACE 2011 Photo #2	
phillips_s_20120306_239.jpg
